# **Design and Implementation of a Motor Drive for Steering a BMW X5 Vehicle**

School of Mechanical Engineering, University of Western Australia

**Final Year Project Thesis**

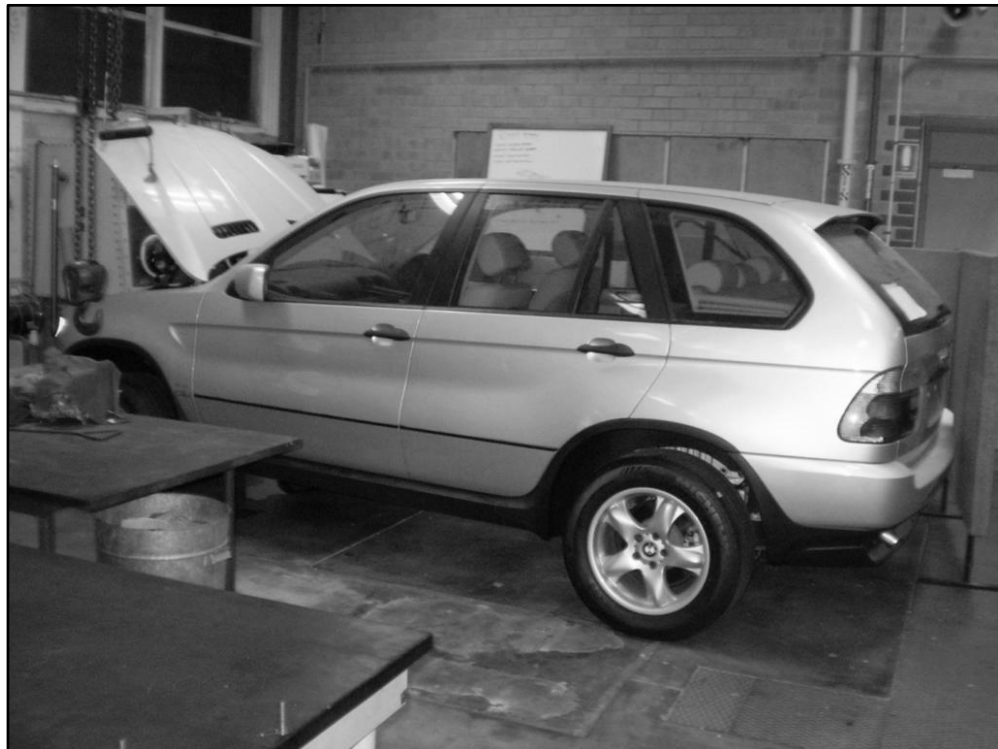
**Figure 1:** BMW X5 Research Vehicle

In order to test the driver assistance programs being developed, a vehicle with electronic actuation of vehicle controls is required. A standard production passenger vehicle, namely a 2001 BMW X5, has been made available for the purpose of automated vehicle control research. The aim of this project is to provide a means of electronically actuating the vehicle's steering controls. An image of the test vehicle is presented in figure 1.

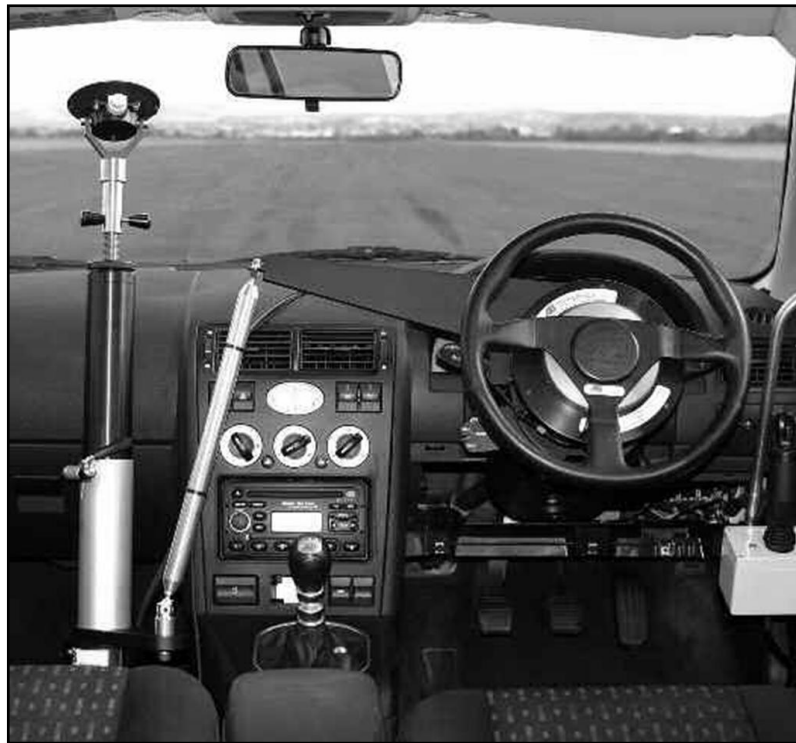
**Figure 2:** Steering Robot (Anthony Best Dynamics)

Retro-fitted commercially available examples of steering actuation can also be found. These are used predominantly in automotive safety testing for vehicle control without an occupant. Anthony Best Dynamics (2007) provide a system which attaches a DC motor to the steering spline directly behind the steering wheel, as shown in figure 2.

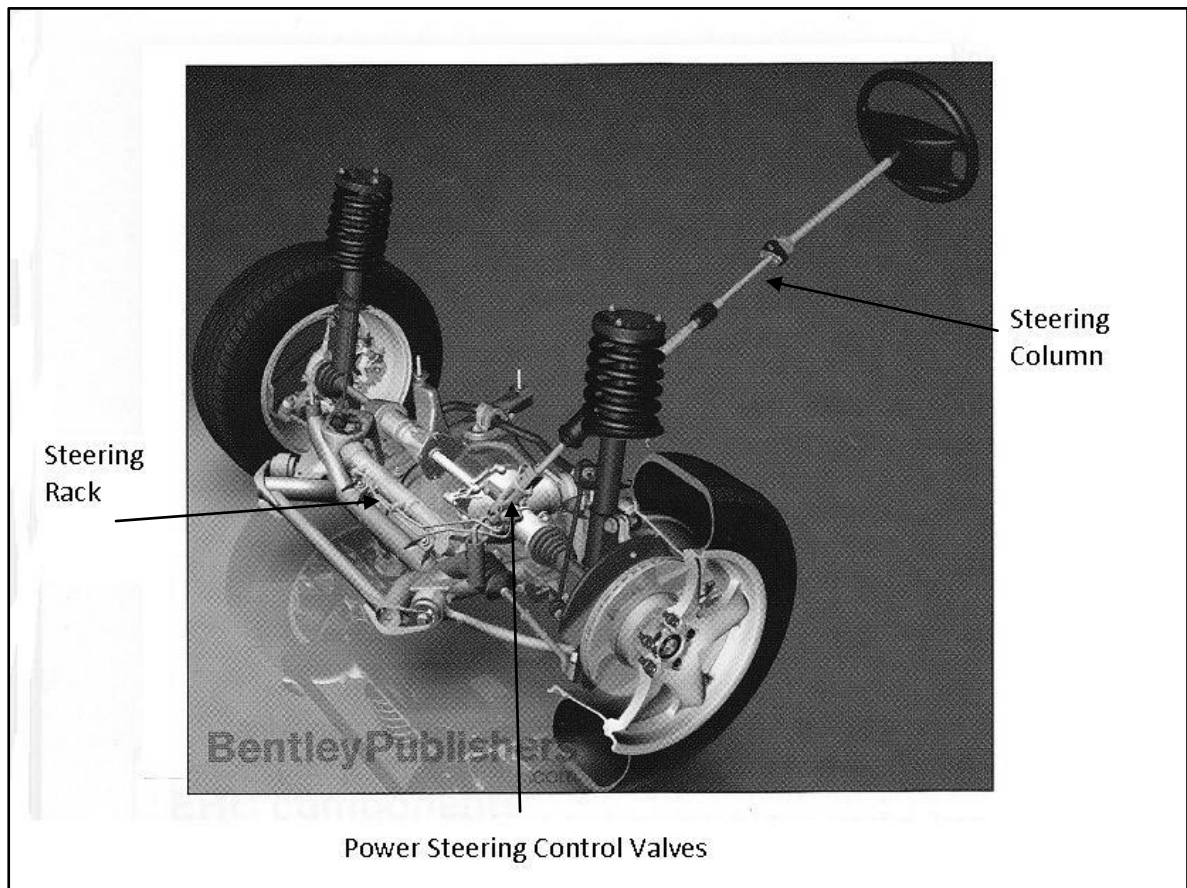
The X5 utilises a power-assisted rack-and-pinion steering system (Bentley 2007). A diagram of the steering assembly, taken from the Bentley (2007) service manual, can be seen in figure 3.

**Figure 3:** Steering System Diagram (Bentley 2007)

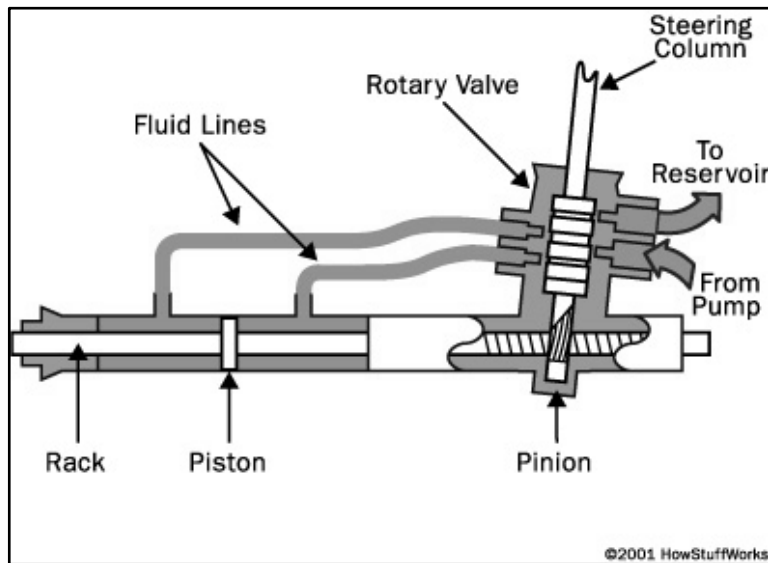
The X5 steering system is composed of three primary elements: the steering column, the rack and pinion gear box and the power assist mechanism. A schematic diagram of the steering assembly displaying all of these elements can be seen in figure 4.

**Figure 4:** Rack and Pinion with Power Assist (Nice 2001)

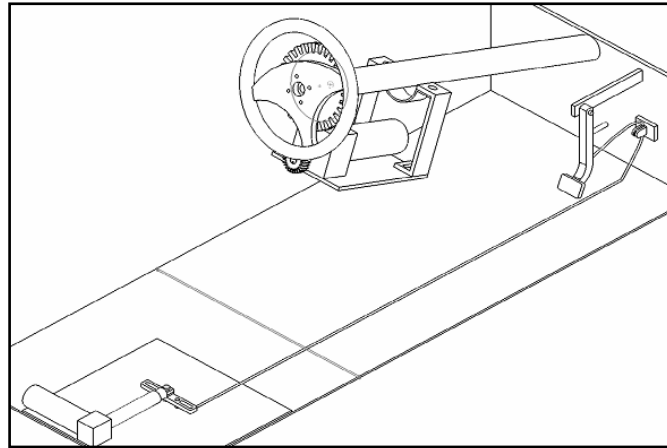
Previous work conducted on the vehicle by Shah (2009) found that the best way to actuate the vehicle steering was to mount a sprocket to the steering wheel, to be actuated by a servo mounted on the underside of the upper steering column. A servo had been procured for the task, the SSPS-105 Tone Servo (Craig Kackert Design Technology Inc n.d.). Initial rendering conducted by Shah (2009) is shown in figure 5.

**Figure 5:** Initial System Rendering (Shah 2009)

Under the design proposed by Shah (2009), a timing pulley would be attached to the steering wheel with the servo mounted on the underside of the steering column. This approach had both strengths and deficiencies. It would have required little if any modification to the vehicle steering system, an important safety and cost consideration. It

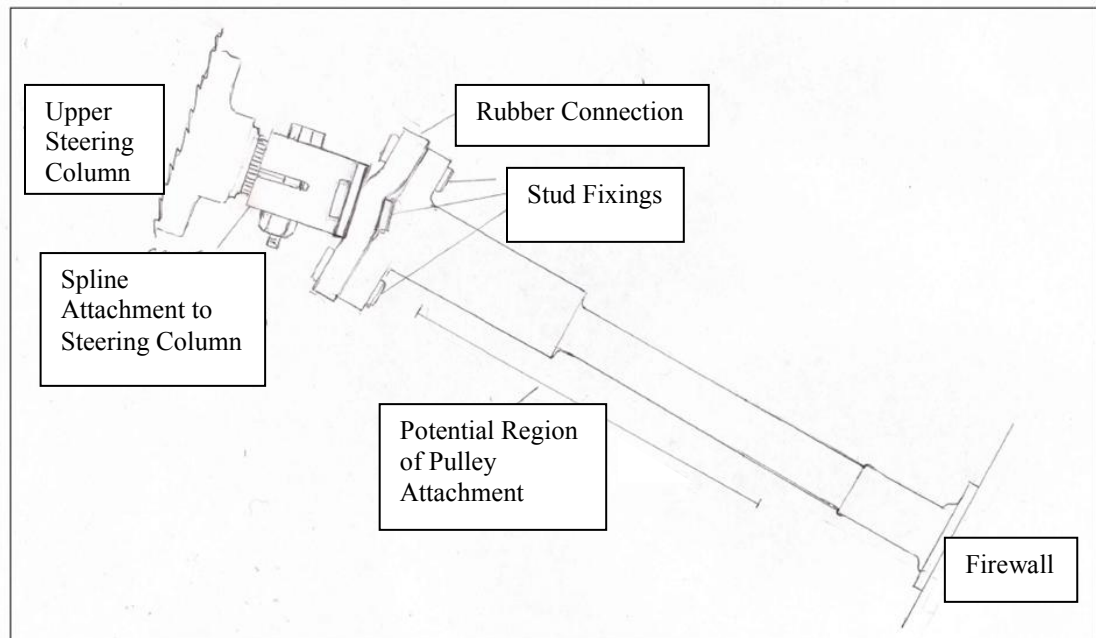
Whereas the previous approach attempted to attach a pulley to the steering wheel and mount the servo to the upper steering column, the idea behind this approach was to attach the shaft directly to the lower section of the steering column. The servo could then be mounted adjacent to the steering column. The section of the steering column under consideration is depicted in figure 6.

**Figure 6:** Lower Steering Column Diagram

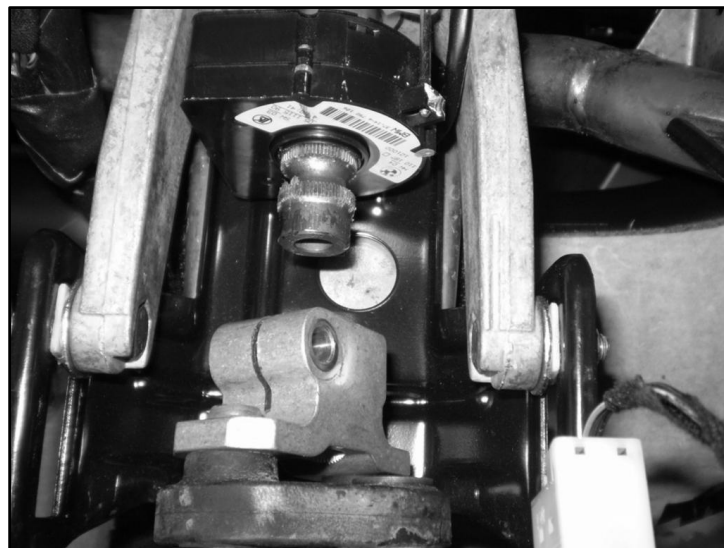
The upper section of the steering column was then removed to allow greater access to the area of interest. This first involved separation of the spline attachment labelled in figure 6. The lower section of the column contains a telescopic joint near the firewall which both provides for adjustment of steering wheel depth and ensures that the steering column collapses forward in the event of an accident. This function also made separation of the spline relatively straightforward, as the lower section of the steering column could simply slide forward after the spline was loosened. The separated spline is shown in figure 8.

**Figure 8:** Separated Steering Spline

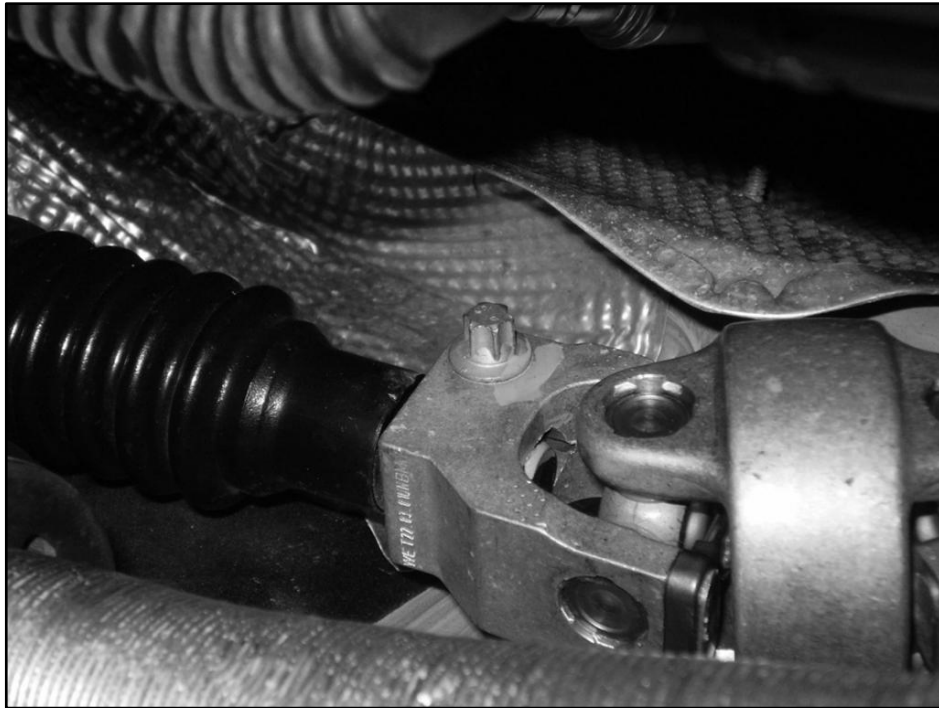
The section of the steering column to which a pulley could be attached is then able to be removed, with the use of a specialised spline fixing (see figure 10).

**Figure 10:** Specialised Bolt Head

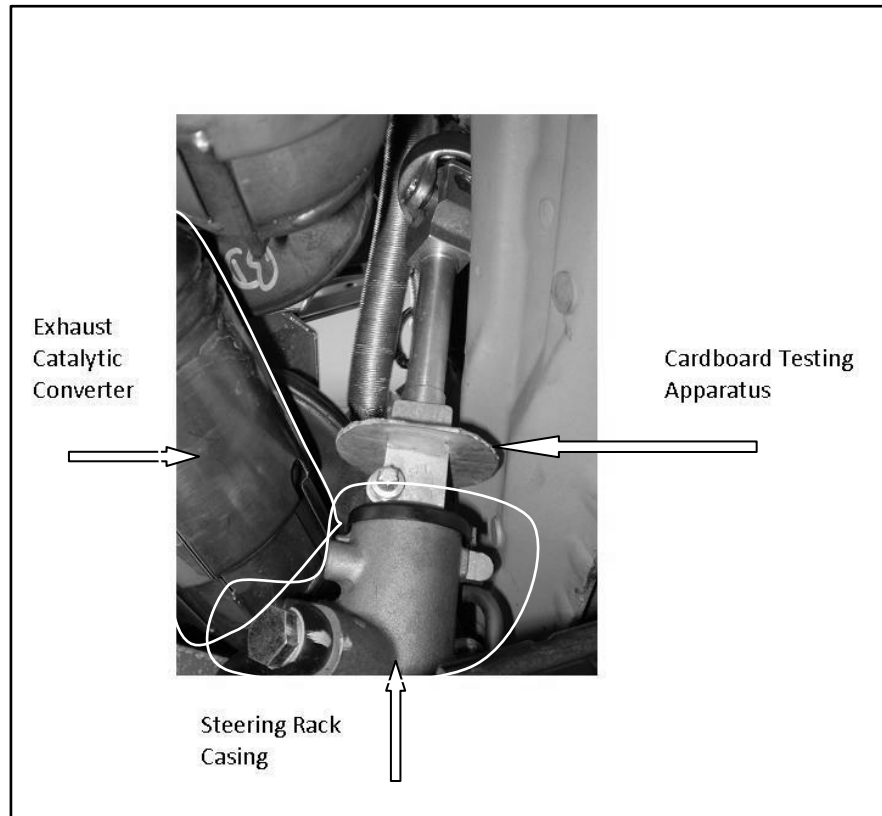
**Figure 12:** Steering Column Located in Engine Bay from Underneath Vehicle; Clearance Testing in Progress

Further, the motor mount was required to provide a heat shield for the belt. The proximity of the belt to the car's catalytic converter, through which all the engine exhaust gases flow, is demonstrated in figure 12. As discussed in the design constraints, the normal operating temperature of a catalytic converter can be as high as 700°C (Annand 1974). Heat radiation from this component could severely damage components of the assembly, particularly the timing belt.

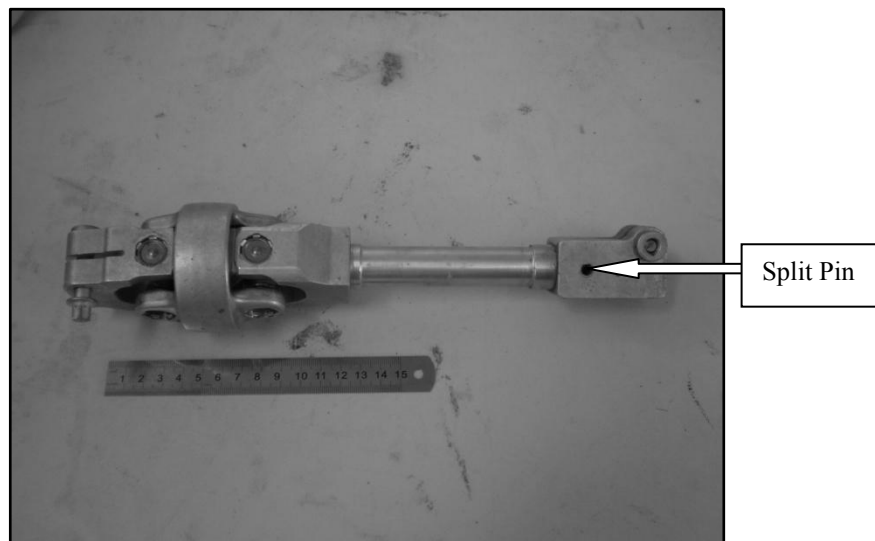
The relevant section of the steering column was able to be removed from the engine bay, as discussed in section 2.4 above. The removed section of the steering column is shown in figure 13.

**Figure 13:** Section of Steering Column Removed, Split Pin Indicated

Due to these difficulties, the design of the pulley attachment had to be modified. By removing a split pin, indicated in figure 13, it was possible to separate the square and round sections of the steering column. The separated square section is depicted in figure 22.

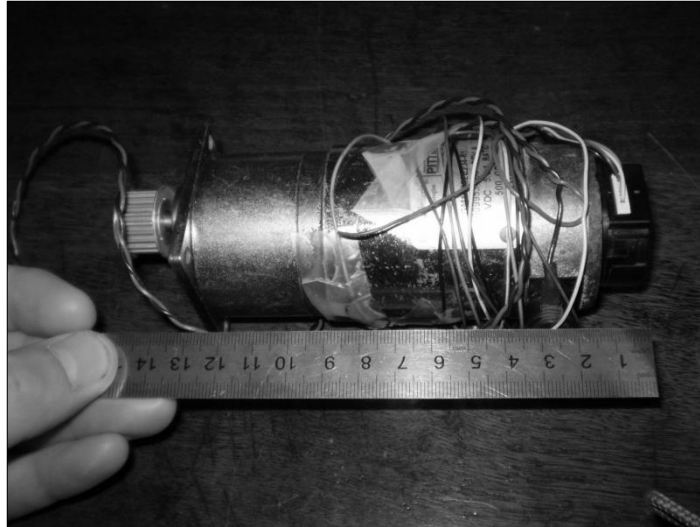
The actuation system required three fundamental components: a drive motor, a custom pulley to be installed on the steering shaft and a mount to constrain the movement of the motor and maintain tension on the belt. A gear-motor was proposed for the task, the Pittman GM14900 series (Pittman 2005). An image of the gear-motor is shown in figure 14.

**Figure 14:** Pittman GM14900 Series Gear-motor

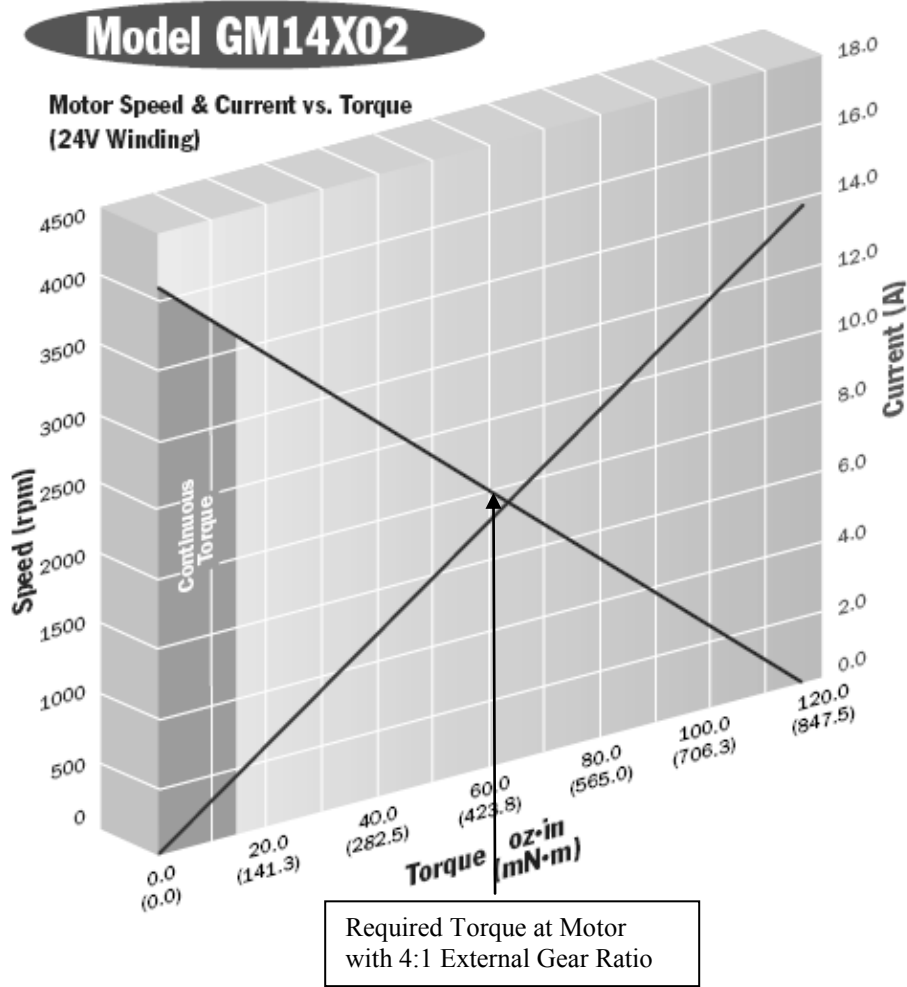
Shah (2009) conducted testing on the X5 and found that the highest steering column torque required to actuate vehicle steering was 10Nm, and that this value was attained with the vehicle stationary. Evaluation of the gear-motor data sheet provided the torque-speed curve for the procured motor, shown in figure 15. The motor was equipped with internal gearing of 5.9:1. An external gear ratio of 4:1 was proposed for the actuator. With these gear ratios, a 10Nm torque at the steering column corresponds to a 424mNm torque at the gear-motor. This approximated value was plotted on the graph and found to be well within operating bounds of the motor, giving a speed of almost 90rpm at the steering column (after gearing has been considered).

**Figure 15:** Torque-Speed Curve of Gear-motor (Pittman 2005)

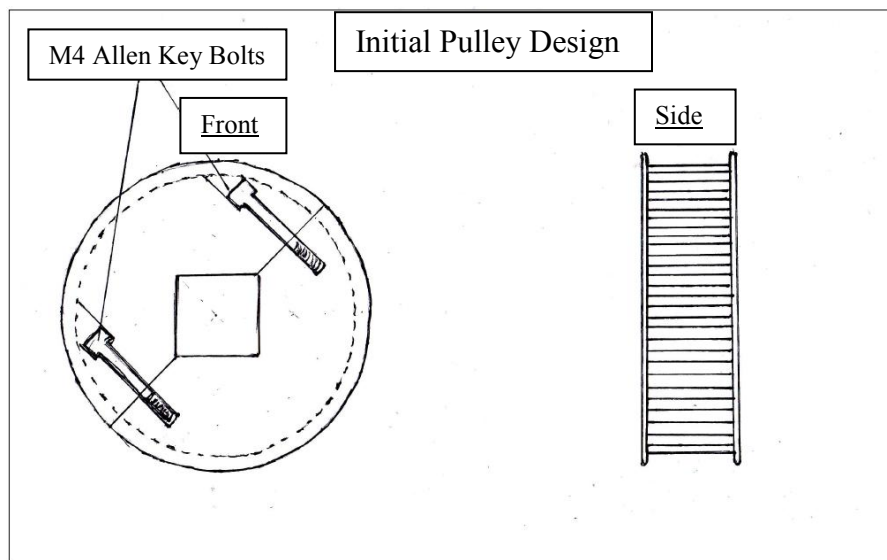
The first design proposed the attachment of a pulley onto the lower square-profile section of the steering column. The proposed design is shown in figure 16. As can be seen, the pulley is split through the middle to allow it to be bolted up either side of the steering column. In order to bolt the pulley together as shown, countersunk holes would need to be drilled on the pulley tooth surface. Attaching the pulley at the square end of the steering column holds two advantages. Firstly, a very positive torque connection is achieved by the square profile compared to attaching the pulley on a round section of the shaft. Secondly, the column has a square profile at its attachment to the steering rack (see figure 12). The column is well supported by bearings at the steering rack. The close proximity of the pulley to the steering rack minimises the moment generated at the bearing by the belt tension force.

**Figure 16:** Initial Pulley Design

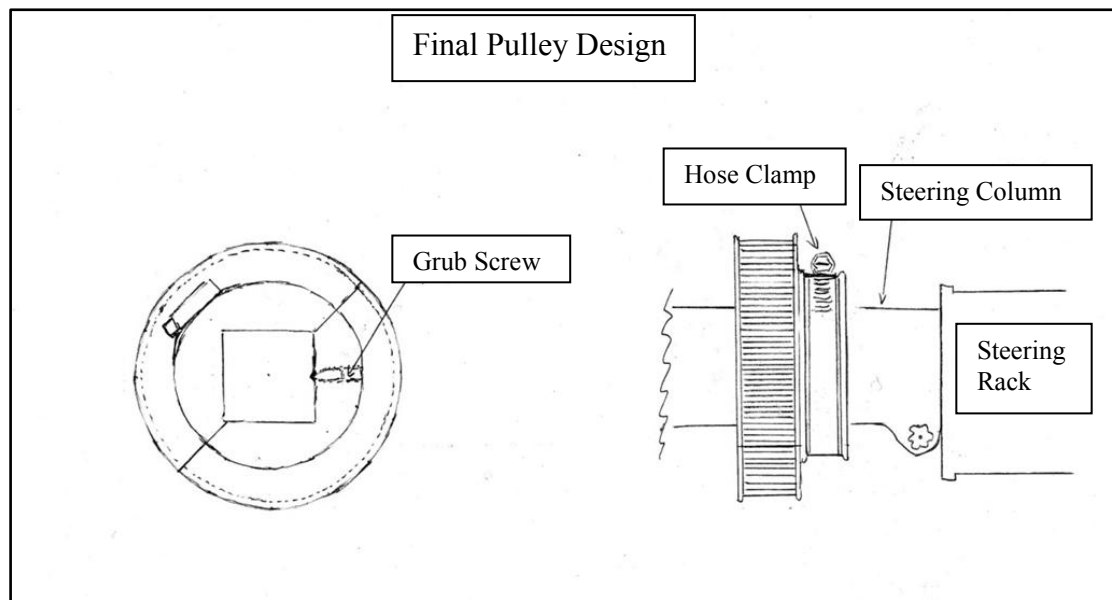
completed in the design phase of the project is depicted in figure 17. Further design work was completed during fabrication. Detailed discussion of this can be found in section 2.7.

**Figure 17:** Final Pulley Design

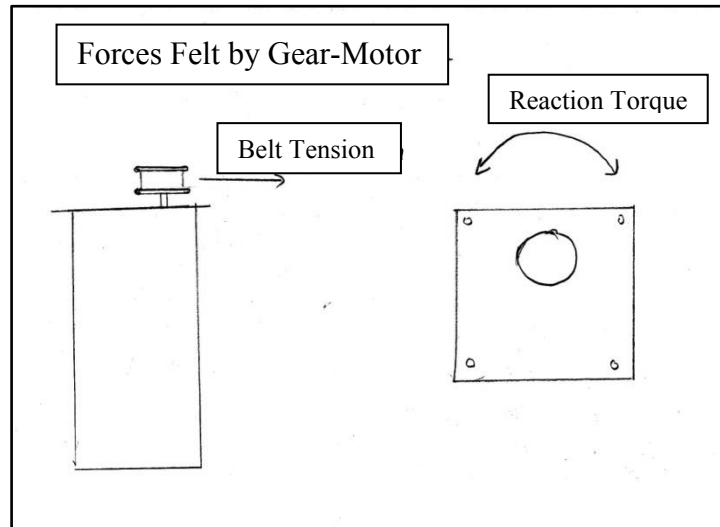
The design of the motor mount was somewhat more challenging as the mount needed to serve several purposes. Its primary purpose is to constrain the movement of the motor in all directions. This requirement must be considered with reference to the directions in which the motor feels the greatest forces. Figure 18 demonstrates the primary forces felt by the motor.

**Figure 18:** Forces Felt by Gear-motor

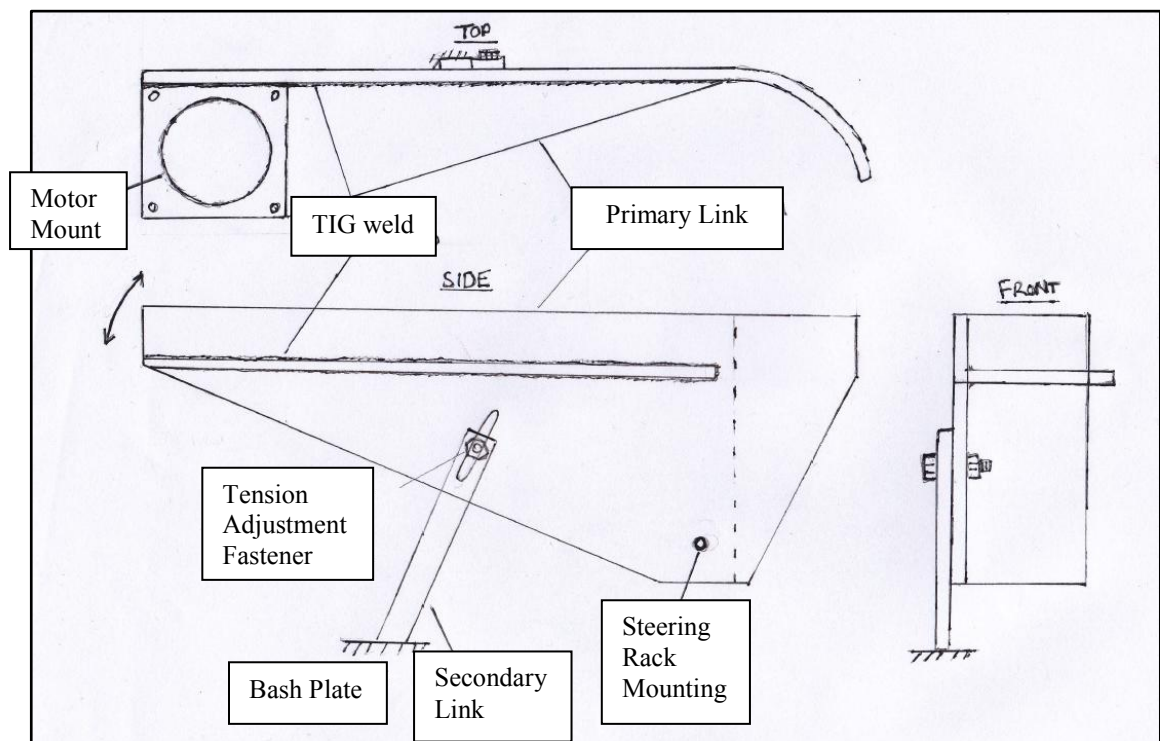
It was decided to use sheet metal aluminium in fabricating the mount, due to its light weight and relative ease of fabrication. Further, sheet metal allows for great flexibility in design as it can effectively be bent into a large variety of shapes. In order to sufficiently constrain the motor, particularly in the direction of belt tension, the mount was designed with flanges bent to increase rigidity. A preliminary design of the motor mount can be seen in figure 19.

**Figure 19:** Preliminary Motor Mount

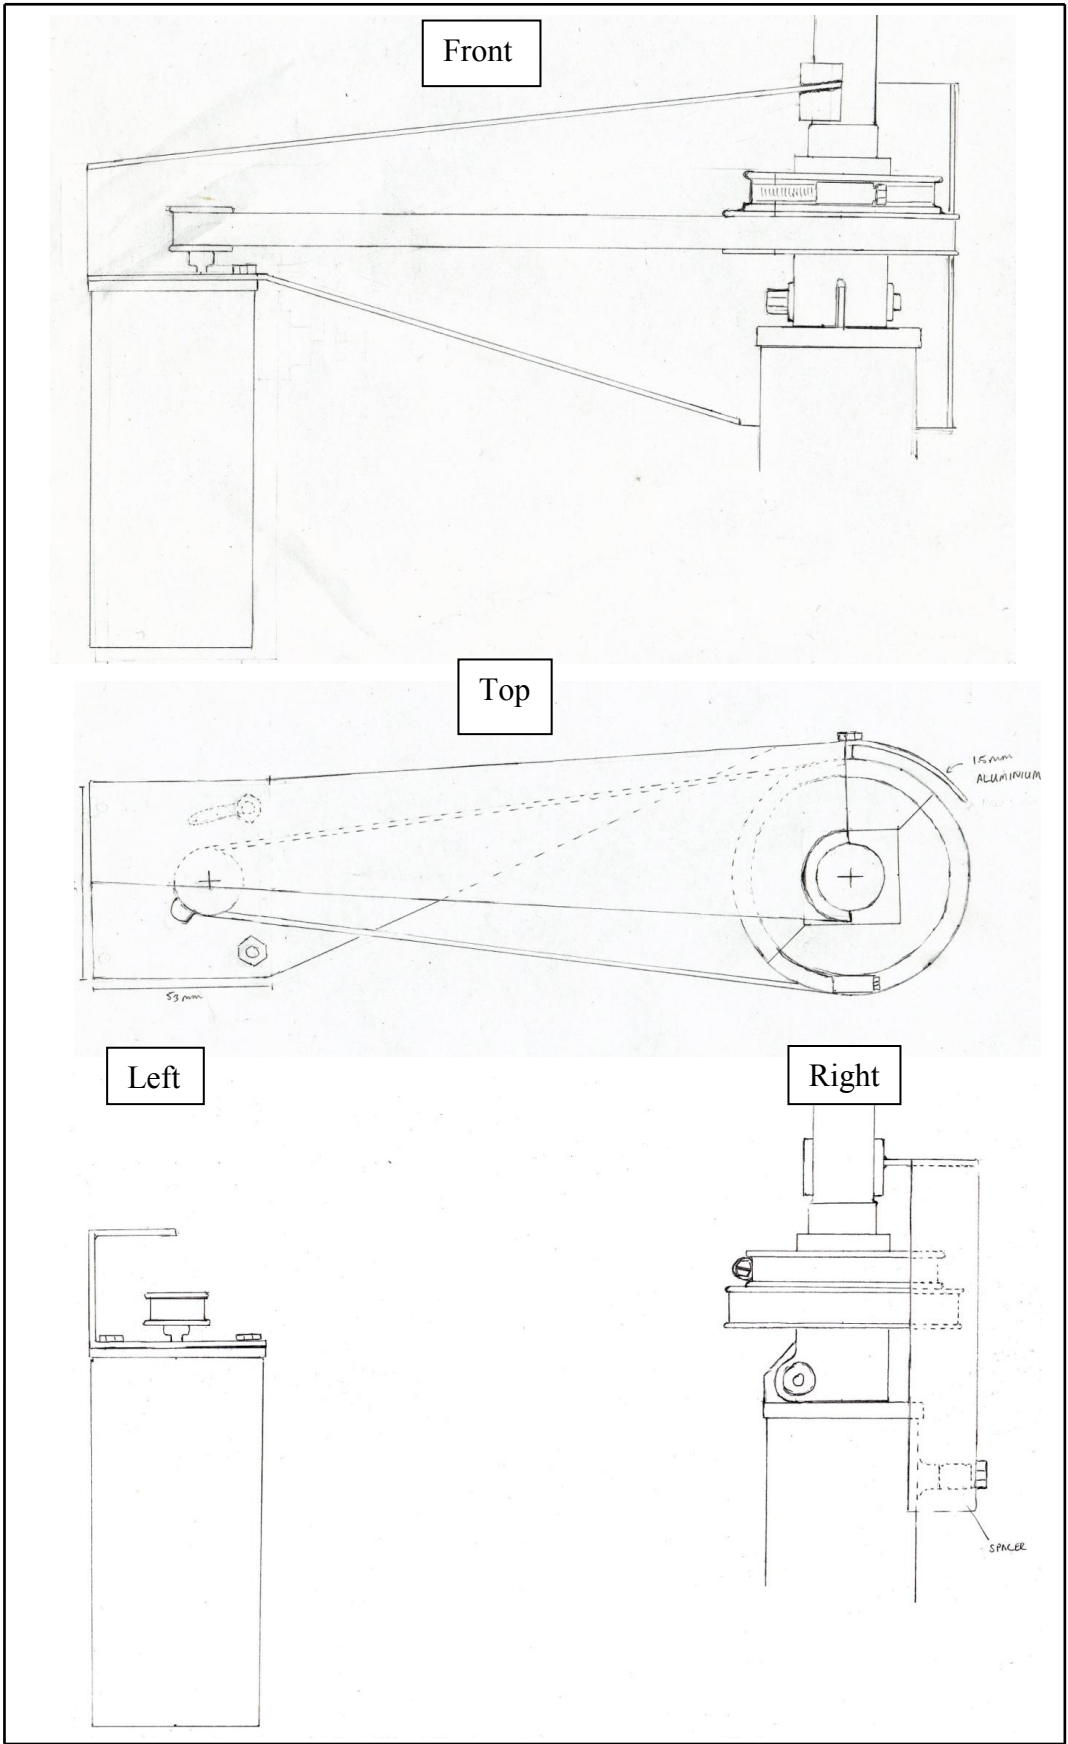
The design was revised, this time to include two mounting points at the steering column. A bearing onto the steering column was added to strengthen the mount in the plane of the belt. Belt tensioning capability was achieved by allowing adjustment of the position of the motor in an arc about one of the mounting bolts. Several design revisions were made before a final design was decided upon. Scale drawings of the final design revision from the front, top, left and right are shown in figure 20. The drawings include representations of the motor, steering column and both drive and shaft pulleys.

**Figure 20:** Final Scale Drawings of Mount Design

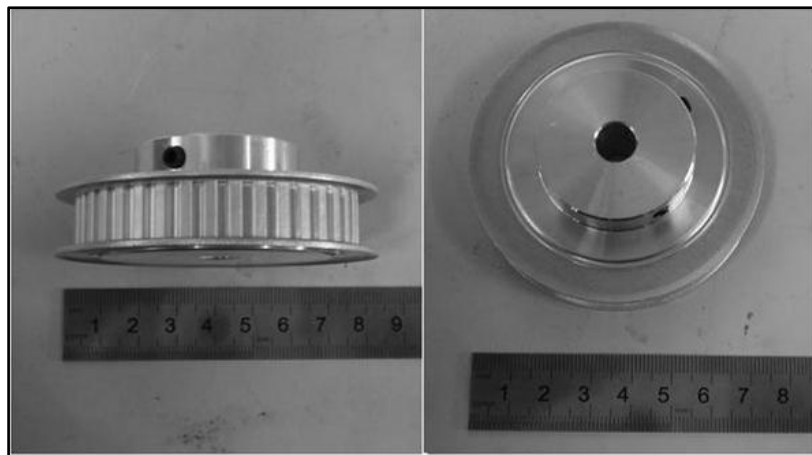
A timing pulley upon which modifications could be made was procured from an American company specialising in Computer Numeric Control (CNC) products. Pulleys such as those procured are used on CNC lathes or milling machines because of their precise positional accuracy. The original pulley is shown in figure 21.

**Figure 21:** Shaft Pulley before Modification

Thus the pulley with its existing flange could not be used in the proposed design. Further, it became apparent that it would be very difficult to maintain the integrity of the pitch profile of the pulley after it had been cut in half. Any change in the geometry of the pulley face would cause the belt to run incorrectly over the pulley.

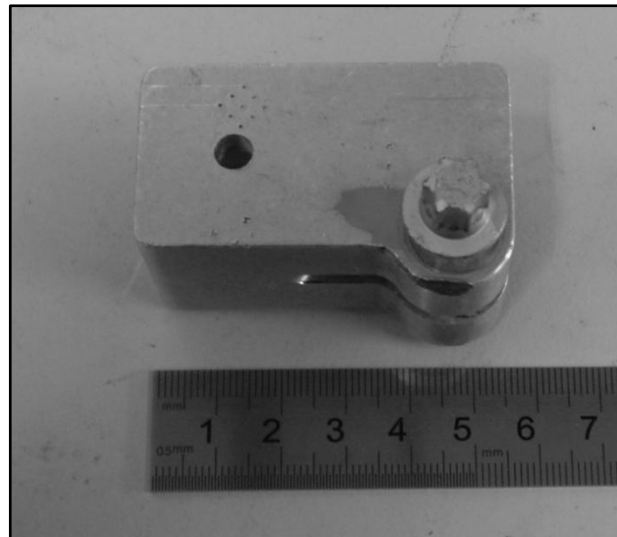
**Figure 22:** Separated Square Section of Steering Column

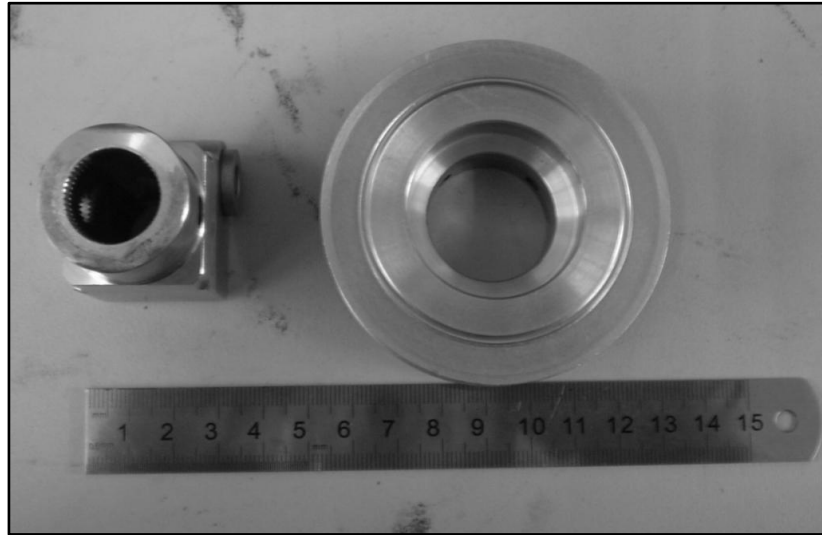
possible, a far more straightforward solution could be found by modifying the steering column. The square section of the steering column was able to be turned down on a lathe and the pulley milled out to a corresponding profile. The final modified components can be seen in figure 23.

**Figure 23:** Modified Pulley and Steering Column

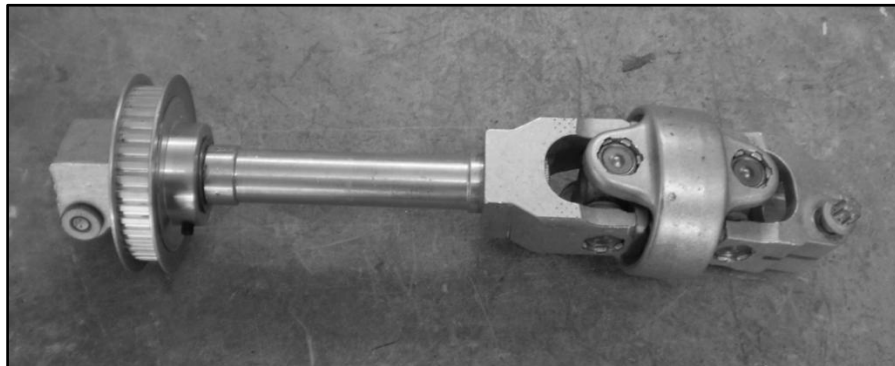
The steering column was then reassembled and split pin reinserted with the shaft pulley loose on the shaft. Dimples were drilled into the column at precise locations into which the two grub screws on the pulley were inserted, locating the pulley. The reassembled steering column complete with shaft pulley is shown in figure 24.

**Figure 24:** Reassembled Steering Column with Shaft Pulley Attached

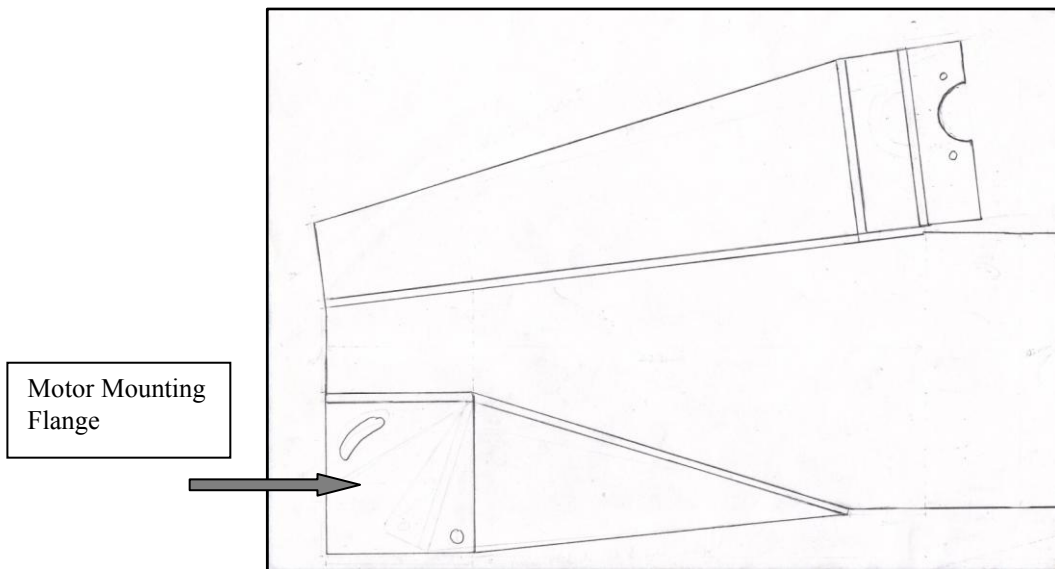
For the fabrication of the motor mount, a piece of 1.5mm 1000 series aluminium sheeting was procured. The mount design was resolved into a single piece of sheet metal with multiple flanges. The preliminary two-dimensional design which was then marked and cut out of sheet metal is shown in figure 25. The mounting point of the motor was designed to allow restricted movement of the motor in an arc. This would allow belt tension to be modified.

**Figure 25:** Original Sheet Metal Template, Mounting Flange Indicated

The flange onto which the motor should mount, indicated in figure 25 (above), proved difficult to fabricate as per the original design. The bend line shown could not be completed without separation of the flange. A vice was used to deform the object in the first attempt at fabrication. This deformation can be seen in figure 26. For the second attempt at mounting, it was determined that the sheet metal should be separated such that a separate flange could support either side of the motor. This revised design is depicted in figure 27.

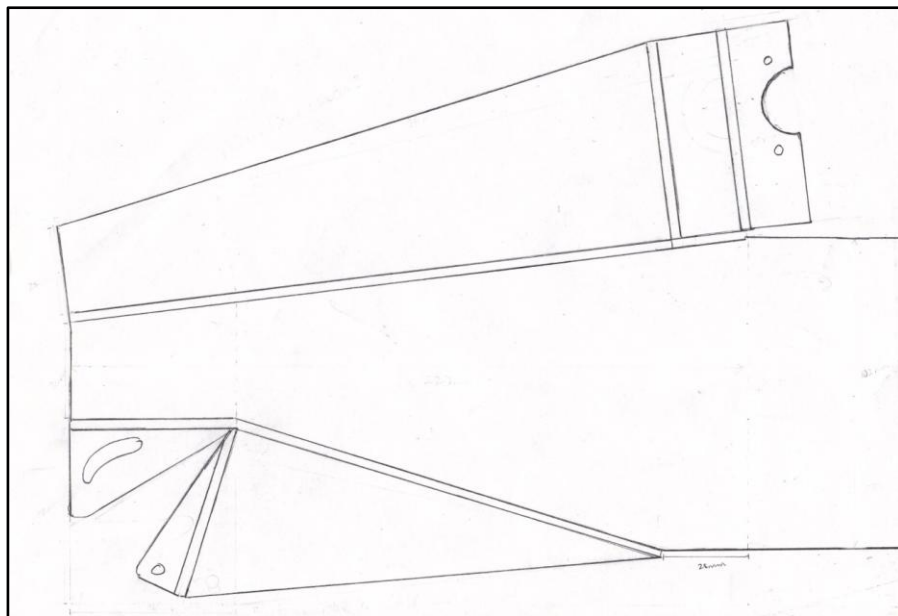
**Figure 27:** Modified Sheet Metal Template

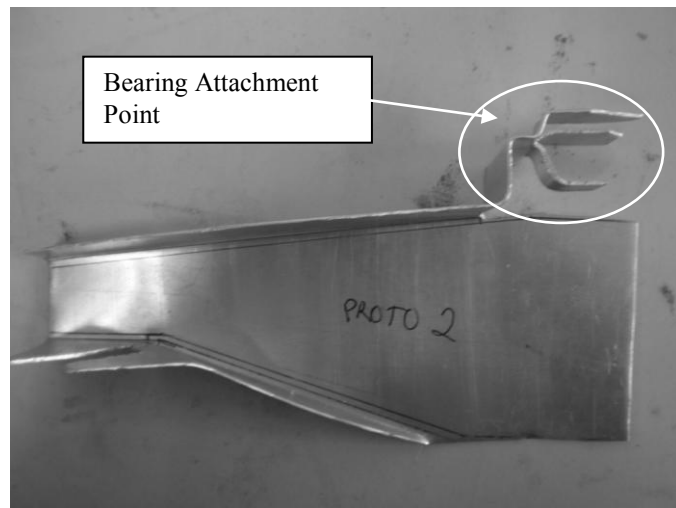
The resulting second mount attempt can be seen in figure 28. The second mount also features a different method of attachment for the shaft bearing, as indicated. Flanges bent from the original piece of aluminium are attached directly to the top and bottom of the bearing. This feature was completed after the template had been used so does not appear on the drawing in figure 27.

**Figure 28:** Mount Prototype 2, Bearing Attachment Indicated

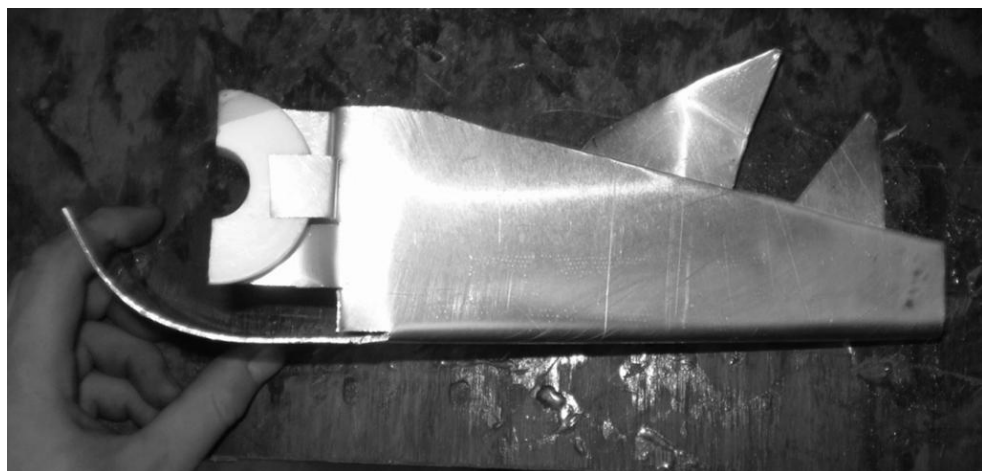
The final fabricated motor mount was made larger to remove the need for a separate flange to be bent up for the purpose of bearing attachment. This final design can be seen in figure 29. Further development included screws to attach each of the three aluminium flanges to the plastic bearing.

**Figure 29:** Final Motor Mount/Heat Shield Prototype

A belt tensioning capability was achieved with the development of an adjustable contact between the motor and the mount. The prototype shown in figure 29 was modified to include this contact. Figure 30 shows the assembled belt tensioning system.

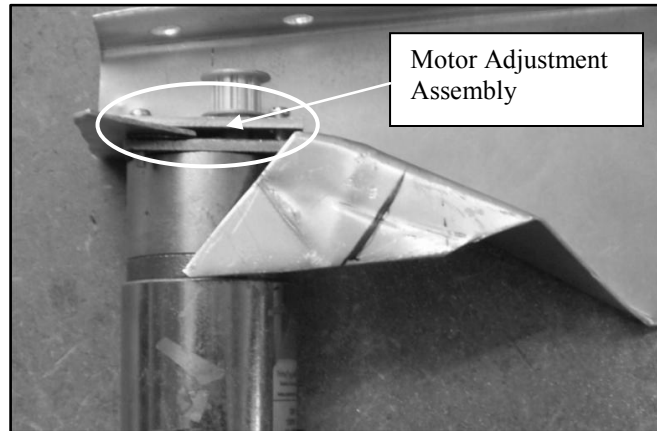
**Figure 30:** Motor Attached to Aluminium Mount with Adjustable Position

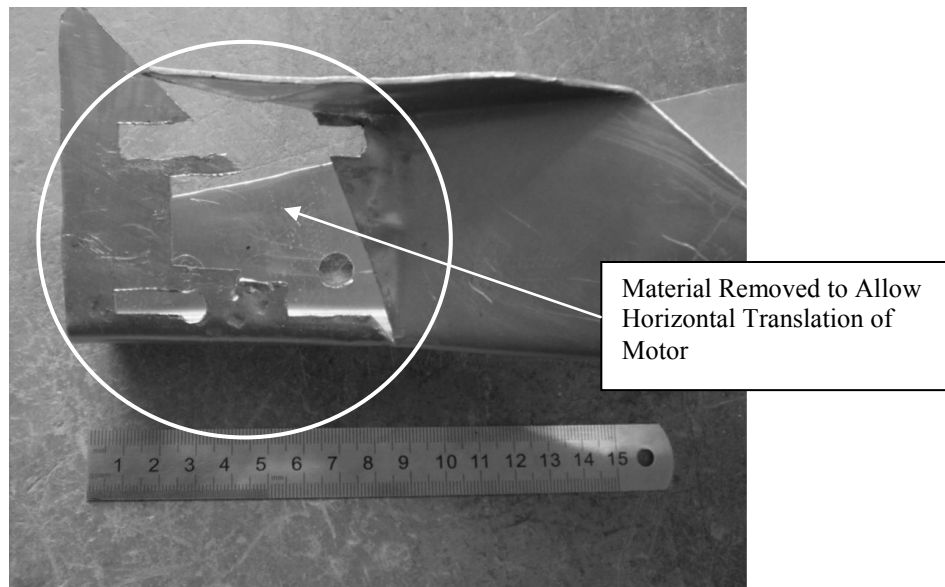
The adjustable contact between motor and mount is constrained by four bolts. These screw directly into threads which are tapped into the plate at the top of the motor. Material was removed from two flanges on the aluminium mount to allow both the bolts and the drive pulley to slide back and forth. The final shape of the two flanges on the aluminium mount is indicated in figure 31.

**Figure 31:** Motor Mount Flanges with Material Removed to Allow Sliding Contact

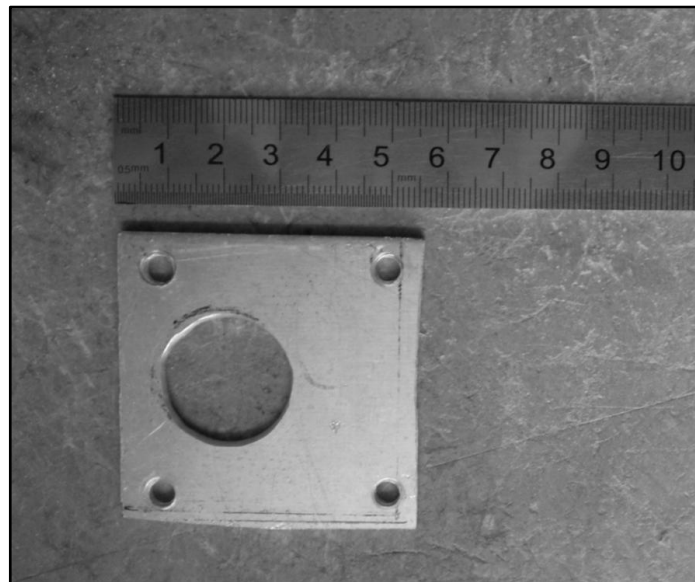
A plate was fabricated to match the profile of the top of the motor. This plate, shown in figure 32, was designed to spread the load created by the tightening of the four bolts over the entire area of the plate.

**Figure 32:** Load Distribution Plate for Adjustable Motor Contact

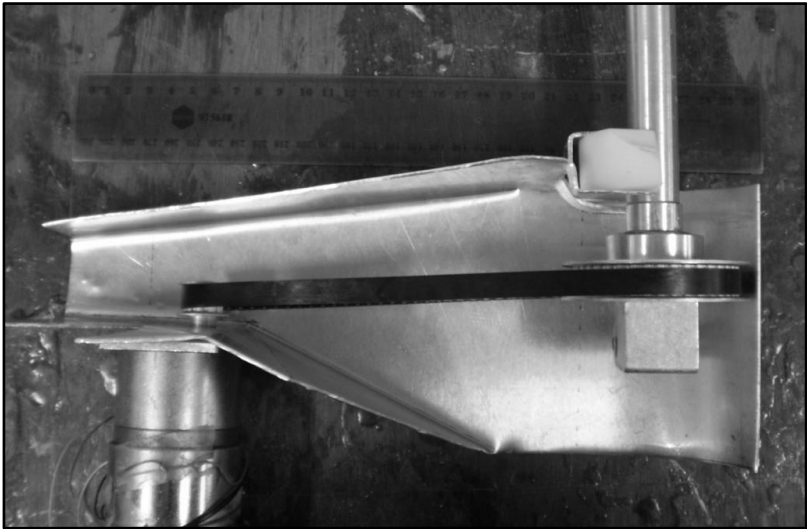
Having determined that an engine bay-mounted motor-belt drive to the steering column was the best method of actuation, designs were attempted, refined and finally fabricated. The final design of the steering system, assembled out of the car, can be seen in figure 33. Due to the close proximity of original vehicle components to those installed, it is impossible to view the entire assembly from one vantage point once installed in the car. Images of the installed system from different directions can be seen in figures 34 and 35.

**Figure 33:** Final Steering Actuation Assembly, Removed From Car

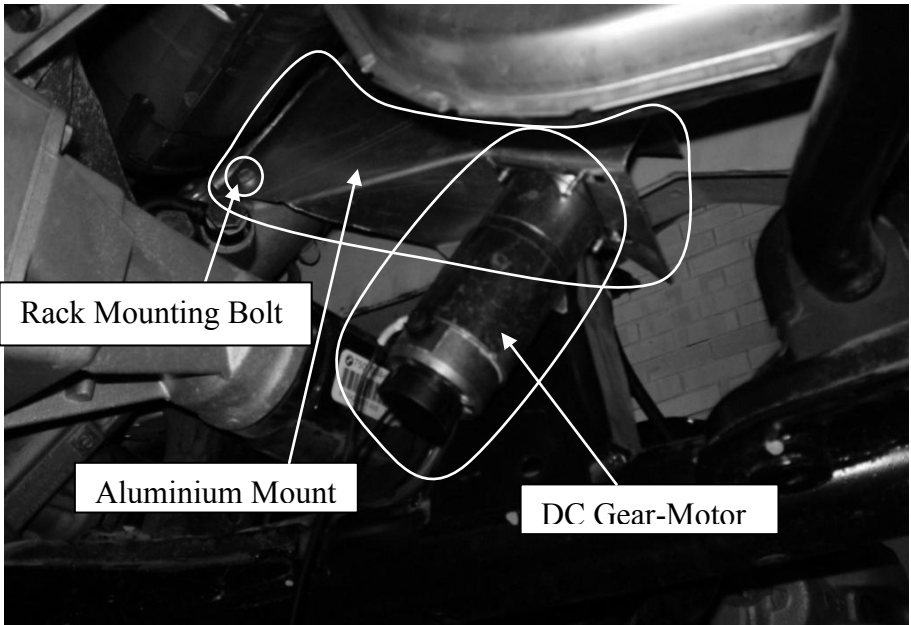
**Figure 34:** Installed Actuation Assembly from Underneath Car, Components Labelled

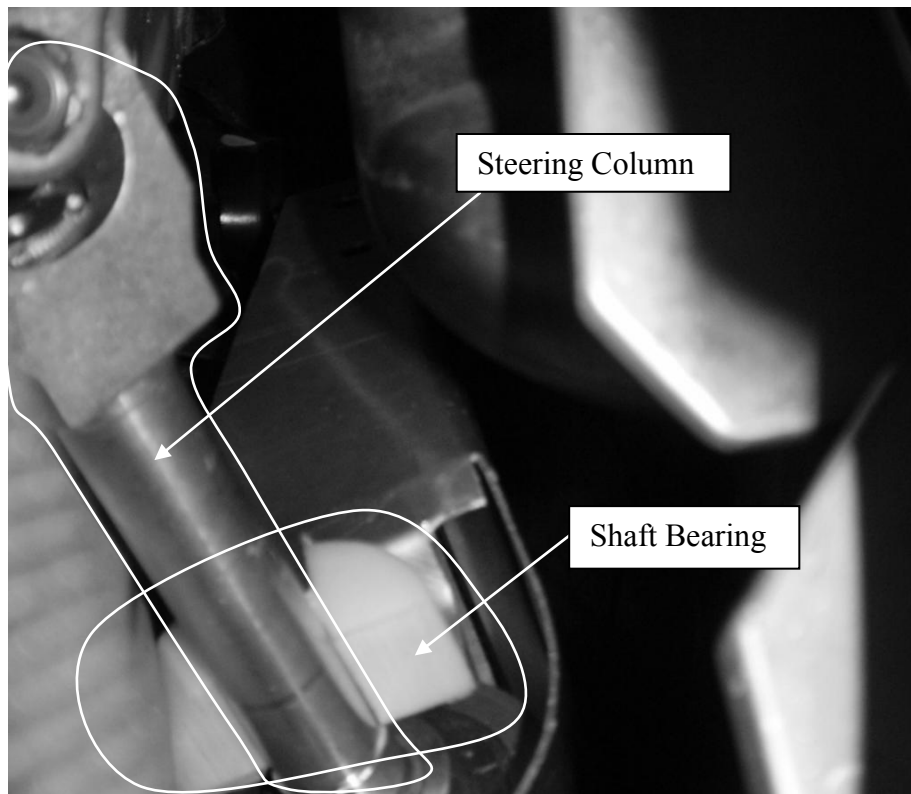
**Figure 35:** Installed Actuation Assembly from Open Bonnet, Looking Towards Rear of Car, Components Labelled

The mount has been designed to be rigid in compression along the axis of the belt. Flanges bent in orthogonal planes ensure the structure resists any tendency to buckle. The structure achieves triangulation of loads with the use of mounting points on both the steering rack casting and the steering column. This triangulation is depicted in figure 36, an annotated drawing of the steering actuation assembly. The rack mounting is obscured in the diagram, but exists behind the rack as seen in figure 34. The steering column mount is achieved through the use of a rudimentary bearing which runs on the shaft (see figure 35).
