# **Design and Implementation of a Motor Drive for Steering a BMW X5 Vehicle**

School of Mechanical Engineering, University of Western Australia

**Final Year Project Thesis**

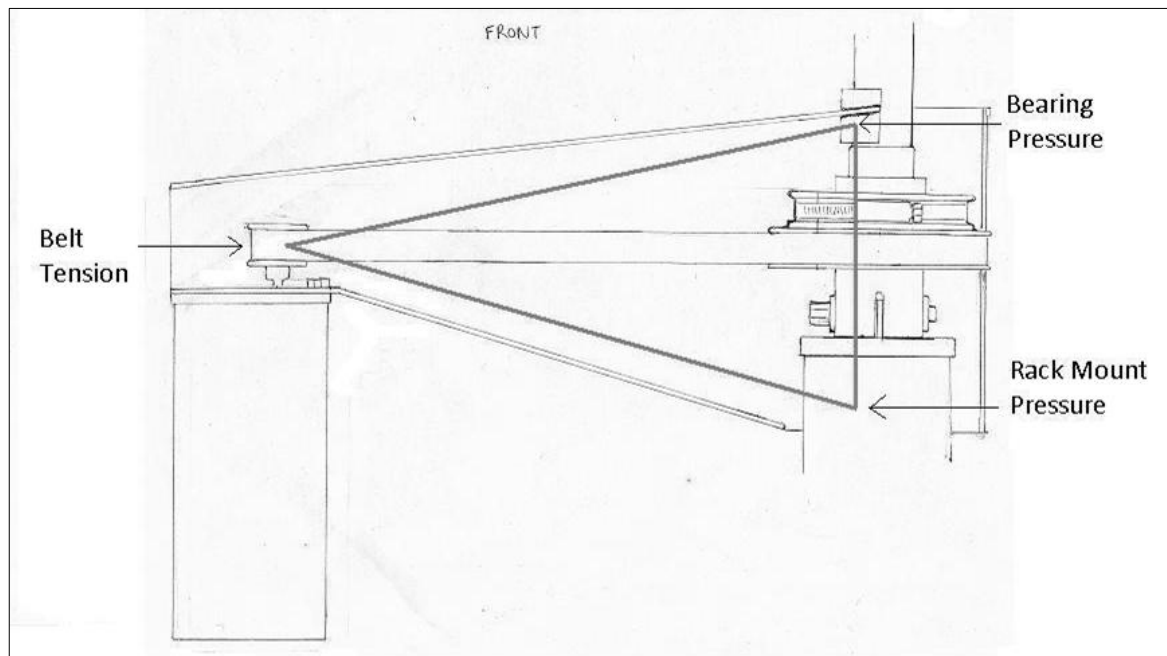
The mount has been designed to be rigid in compression along the axis of the belt. Flanges bent in orthogonal planes ensure the structure resists any tendency to buckle. The structure achieves triangulation of loads with the use of mounting points on both the steering rack casting and the steering column. This triangulation is depicted in figure 36, an annotated drawing of the steering actuation assembly. The rack mounting is obscured in the diagram, but exists behind the rack as seen in figure 34. The steering column mount is achieved through the use of a rudimentary bearing which runs on the shaft (see figure 35).

**Figure 36:** Steering Actuation Assembly, Triangulation of Forces on Mount Indicated

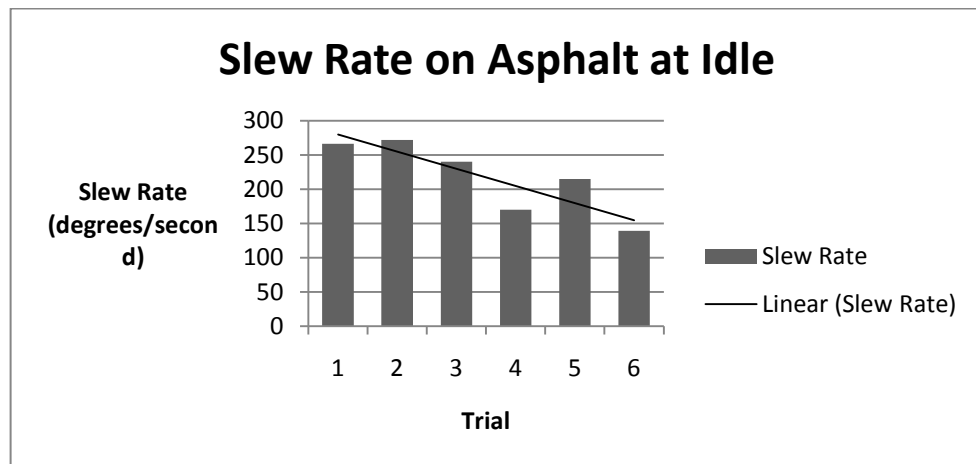
The rate of steering column angle change (slew rate) was determined by recording the time taken for the steering rack to travel from full lock in one direction to full lock in the other. The angular displacement of the steering column over this range is 3.4 turns or 1224° (Shah 2009). Each trial was commenced within a few seconds of the previous one. This experiment was initially conducted on an asphalt surface with the vehicle stationary and idling. These conditions were used as they were deemed to create a high torque scenario for the actuator. The results are presented in figure 38.

**Figure 37:** Slew Rate on an Asphalt Surface with Engine at Idle

The average slew rate over all six trials was found to be quite healthy at a value of approximately 217 °/second. However, it is clear from examining this data that the slew rate provided by the actuator was quite volatile and generally fell with consecutive trials performed. When the actuator was unused for a few minutes, the slew rate returned to the higher values seen in the first two trials.

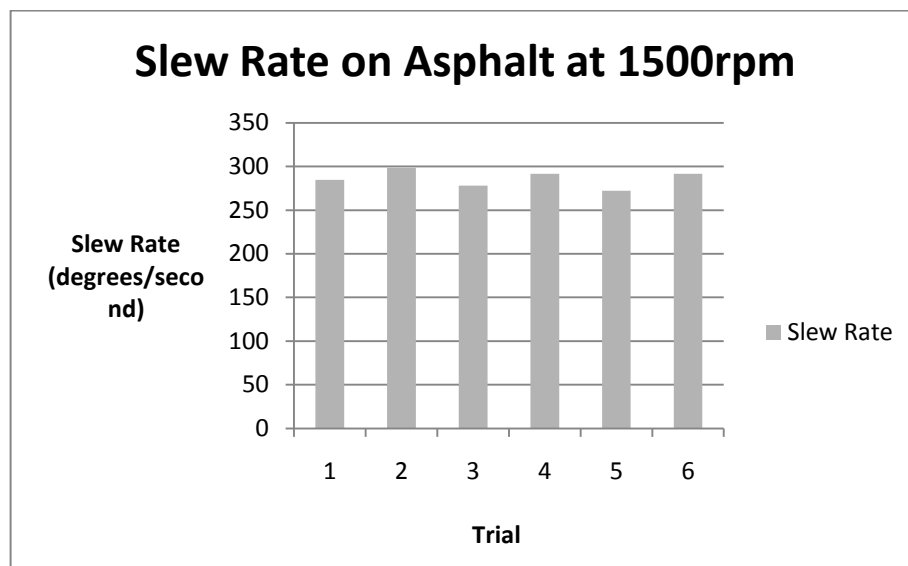
It was proposed that the reason this drop in slew rate was occurring was that the car's alternator could not provide sufficient current to maintain 12 volts at the car battery after consecutive trials. The actuator was drawing more current than that provided by the alternator and as such the battery voltage was dropping over time. This hypothesis was tested by again measuring slew rate of consecutive trials, but this time the engine speed of the car was held at approximately 1500rpm. The theory of this approach was that at 1500rpm – approximately double the engine idle speed – the current provided by the alternator would be far greater. This greater current should allow the battery to better maintain its voltage over consecutive trials, allowing slew rate to remain constant or at least to fall more gradually. The results are presented in figure 39.

**Figure 38:** Slew Rate on an Asphalt Surface with Engine Running at 1500rpm

The average slew rate over this second set of results was found to be 286°/second, a rise of approximately 31% over the average rate with the engine at idle. More significantly, the

These results support the hypothesis that the current drawn by the actuator causes the car battery to experience a voltage drop over consecutive trials with the engine running at idle. They showed that by increasing engine speed to 1500rpm, the power provided by the car's alternator is sufficient to prevent voltage drop.

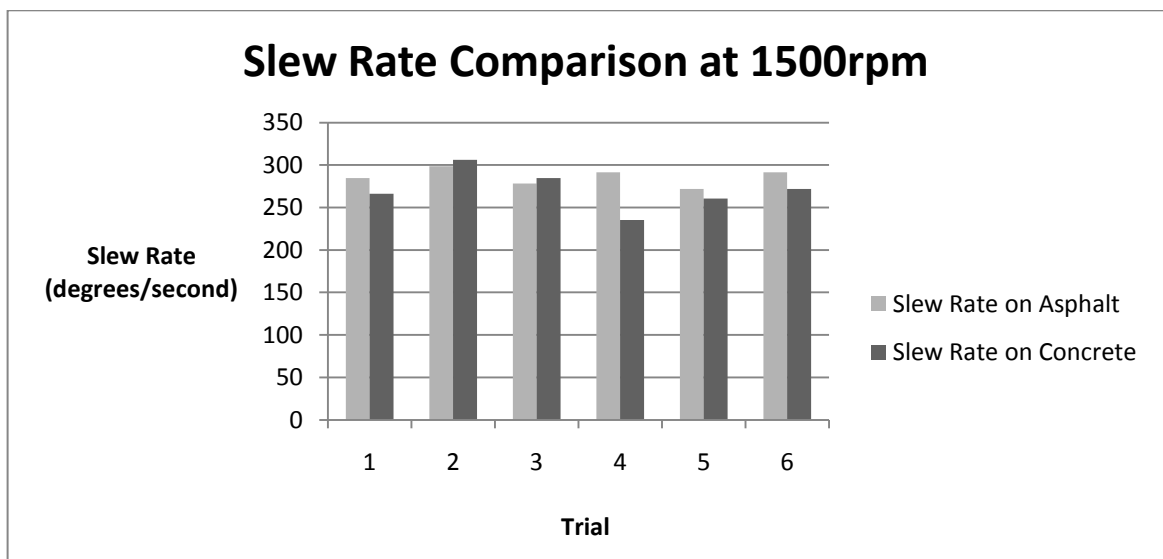
Further testing of slew rate was conducted on smooth concrete. The results of testing on concrete vs. asphalt are presented in figure 39.

**Figure 39:** Slew Rate Surface Comparison

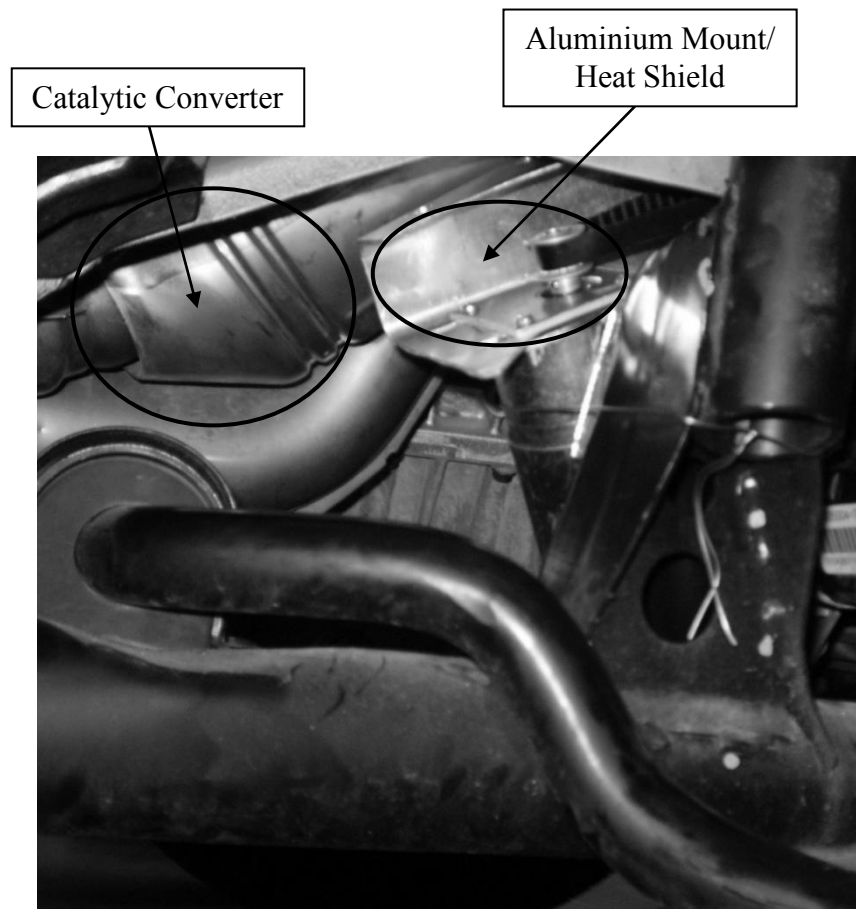
In order to determine thermal performance, an infra-red thermometer was used to determine the operating temperature of different components. Unfortunately, due to the congested nature of the space in which the system is mounted, the only temperatures which were able to be measured were those of the aluminium mount and the adjacent catalytic converter. The area which was measured for thermal performance is shown in figure 40.

**Figure 40:** Back of Actuation Assembly Mounted in Car, Objects Used for Thermal Analysis Labelled

It can be seen from the results collected that the motor mount is reasonably effective in providing a thermal barrier to the actuation assembly. The catalytic converter, which is adjacent to the aluminium mount, averaged an external temperature of 161 °C, while the aluminium mount averaged only 45.4 °C. A temperature of 45.4°C is comfortably within the operating temperature range of the belt being used to drive the steering column. A more detailed study of thermal performance would be required to be sure the system is thermally protected under all operating conditions.

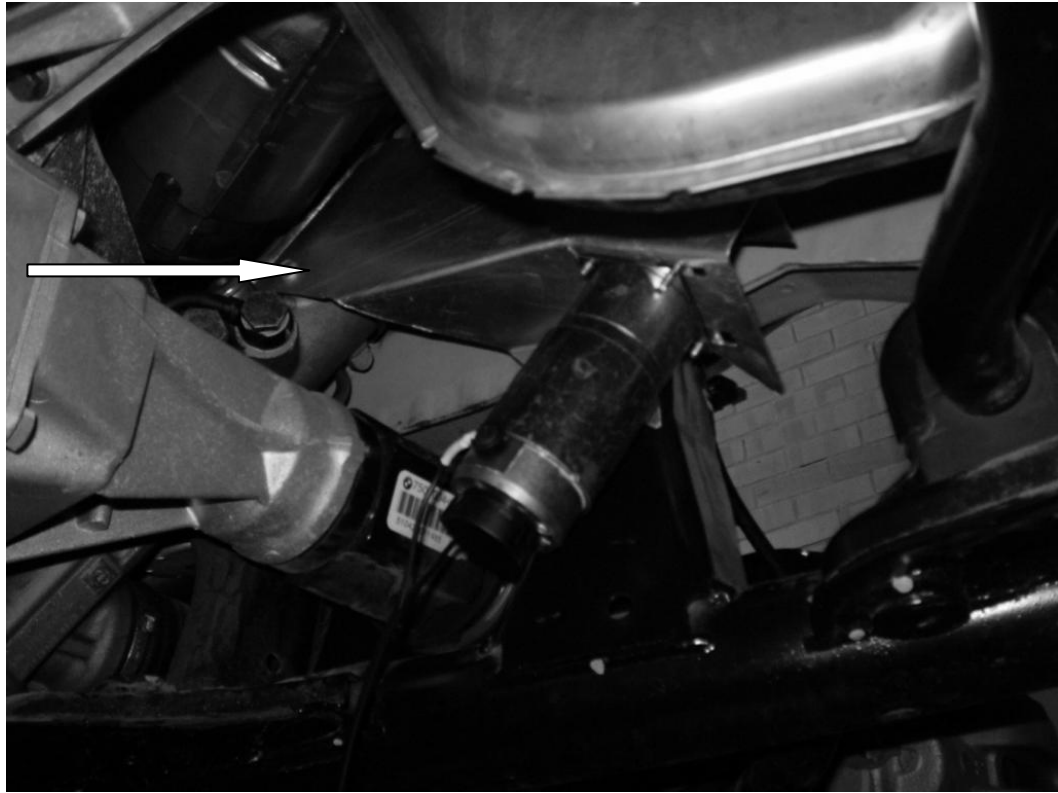
**Figure 41:** Installed Actuation System From Beneath Car, Steering Rack Mounting Bolt Indicated

- First, cut the wire which holds the gear-motor to the chassis upright
- Then, remove the bolt which attaches the aluminium mount to the steering rack (indicated in Figure 1). Applying a slight upward pressure to the mount to take the belt tension force off this bolt will make your task easier.

- You should now be able to swing the mount down slightly, to relieve tension from the belt. Slide the belt off the drive pulley and draw the mount and servo out of the cavity, taking care not to damage the shaft pulley or aluminium mount in the process.

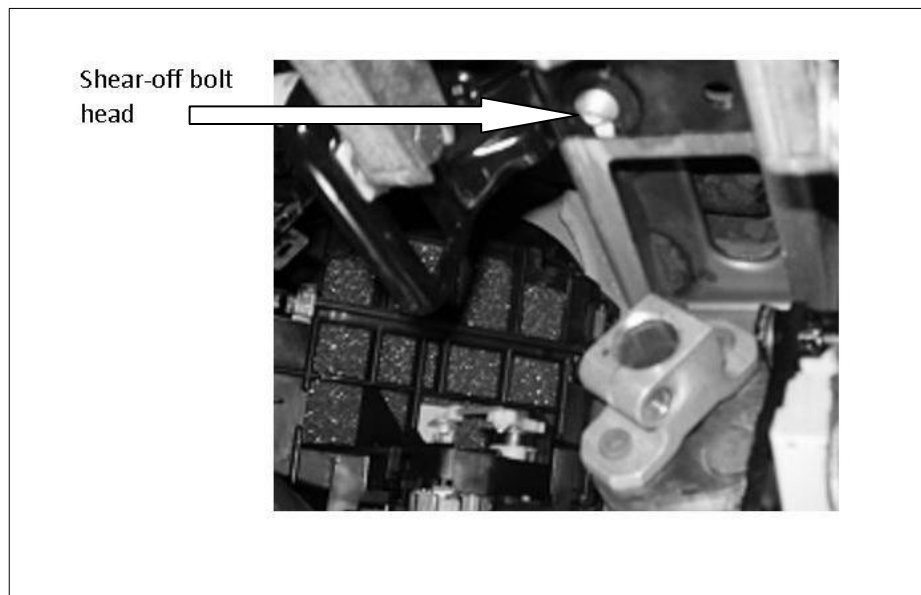
The shear-off bolt was installed by BMW to ensure the steering column, a vital safety feature of the car, was not tampered with by an unqualified technician. At installation, the bolt head was sheared-off, leaving a conical shaped fastener onto which no fitting could be attached. An image of the bolt installed in the car is shown in figure 1. The shear-off bolt proved very difficult to remove.

**Figure 1:** Shear-off Bolt

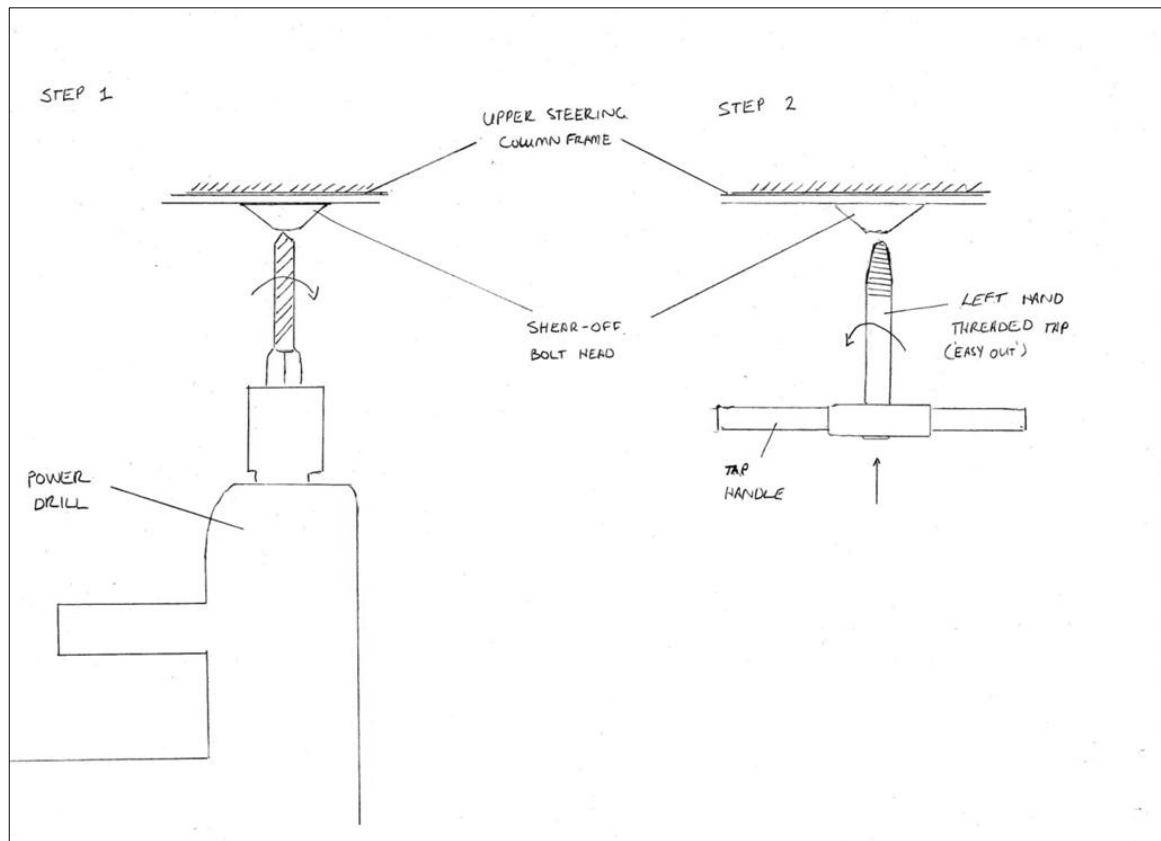
First, a hole was drilled into the top of the conical head. A left-hand threaded tapered tap, known as an ‘easy-out’ was then pushed into the hole and rotated anti-clockwise. The intention was for the easy-out to begin to thread the hole and use the thread and widening taper to impart torque on the bolt in an anticlockwise direction. The two stage operation is depicted in figure 2. Unfortunately this approach was unsuccessful as the threaded hole could not provide enough torque to loosen the bolt. The thread in the hole was instead stripped when loosening was attempted.

**Figure 2:** Attempted Method to Remove Shear-off Bolt
