SOLAR POWERED AUTONOMOUS RAFT (SPAR) FINAL YEAR RESEARCH PROJECT THESIS

This thesis is presented for the degree of Master of Professional Engineering of The University of Western Australia School of Mechanical and Chemical Engineering

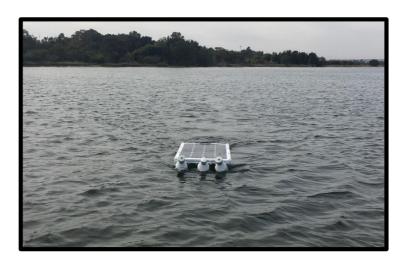
Figure 6: Front View of the SPAR while testing

The SPAR is a PVC multihull marine vessel with an aluminium frame, steel fixtures and some 3D printed parts. The issues with having multiple metals in the severely corrosive environment is discussed further in this report. All the parts except for the aluminium frame can be purchased from local hardware stores. This difference is because the structure is a very robust patented, anodised extrusion that was given to the project team for free by a local manufacturer. If it is damaged in the future, it can be switched out for a steel frame with only a few design changes. The physical system revolved mostly around the dimensions of the solar panel shown in the technical drawings, Appendix 13. These dimensions determined the frame size and in turn the number of PVC pipes needed. The saddles are designed to attach PVC pipes to walls as downpipes, they were cold worked and adjusted to fit the needs of the project. The front hull angle utilises 45-degree bends and reducer parts to create the high profile, shown in Figure 6 below. The design team decided the front of the PVC pipes needed to be accessed for future improvements so a screw cap was made up that allows access while not letting water in to the internal pipe. The rear of the PVC pipe uses an end screw cap with a rubber O-ring, these were well tested for leaks before putting electrical equipment inside. The SPAR has a velocity between 1-2 m/s while experimenting on the Swan River; it was designed for 1.3 m/s (Hodge, 2017) and so is within a reasonable range. Current testing is focusing on making the propulsion system efficient to gain a more accurate estimate of the SPAR's velocity. Through trial and maintenance, some smaller revisions have been made to the overall physical design. 3D printed parts are notoriously porous and some wear and tear was noticed; so they have been filled with epoxy resin and have been robust since. A solar garden light has been retrofitted onto a flagpole and can be attached to the SPAR for overnight voyages. This is used for the safety of the SPAR and to meet Maritime Standards (COLREG, 2003). Metallic fixtures that have corroded have been switched with galvanic elements and covered with paint. This is discussed further in section 6.2 along with how silicon was used to reduce residual water build-up.

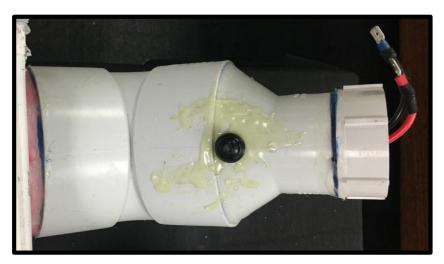
Figure 7: External Switch 22

The external switch wasn't initially considered to be vital, but the 7th Test in Appendix 4 displayed its importance. It is connected to the Arducopter switch so the boat's solar regulator can be turned on without the controller and electrical equipment turned on. Having an external switch has increased the amount of testing possible. Additionally, the sustainability of the electrical components increased because the electrical board doesn't need to be removed.

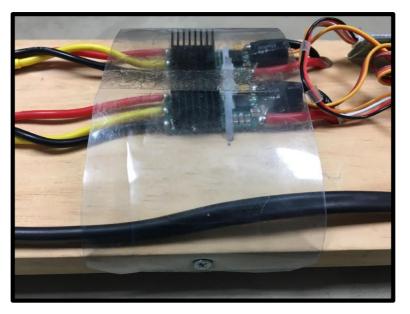
Figure 8: Plastic Coverings

The significant portion of the damage occurring to the electrical board occurs when the board is loaded into the PVC pipes. This was shown to be an unavoidable issue during the 5th test and needed to be remedied before any significant testing was conducted. A few solutions were considered, but due to the dimension restrictions, a plastic covering from a water bottle was used. This gave the wiring convex protection that fits well with the PVC pipes. There has been no significant damage since the covers were implemented. Additionally, the plastic covers can be unscrewed when work needs to be done on the electrical components underneath.

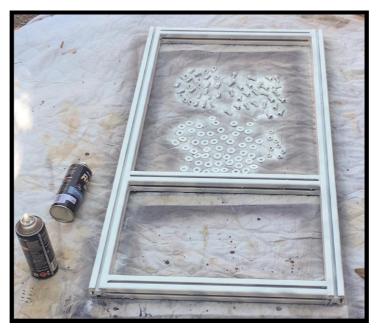
Figure 13: Final Coat of Spray Paint

There are many ways to slow or stop corrosion; the relevant ones are shown in Table 14. The surface covering, in the form of spray painting has been chosen as the ideal solution because cheap, easy to source parts and quick to implement compared to the other options. All purpose primer spray paint was used first because of the different materials used due to there being small amounts of corrosion sporadically on the parts. Then once that was dry a white epoxy enamel spray paint was applied. Each section was sprayed twice with each can because spray paint doesn't touch 100% of a surface. This was a, and realistically the pieces will have 2-4 protective coats. Figure 13 shows a number of the elements after the white coat; the primer coat is shown as the dark grey residue on the sheet. Small missed spots were touched up once the SPAR was reassembled. The spray paint has a rating for five years but due to the hard environment that the SPAR is working within it should be checked every six months.

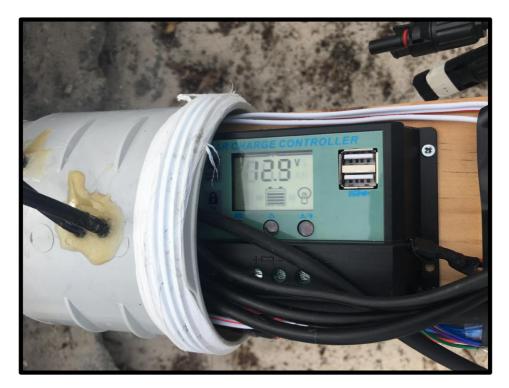
Figure 23: Post Test Battery Check

during this test was initially thought to be one of the thrusters switching off when adjusting the route. This was later found out that one of the thrusters is actually reversing to turn. This is fine when on land but in water the SPAR is losing a significant amount of inertia every time it adjusts. Voltage warnings occur when the voltage gets close to 10 V. They started happening after waypoint 12 and steadily become more frequent, by waypoint 16 they were at least once every 30 s. On a positive note the SPAR held a constant velocity throughout the test The thruster had a sharp impact and came dislodged, underneath water had gotten into the 3D printed part. Looking at the internal displayed a honeycomb pattern and that the piece is far more porous than previously known. Searching through the APM Planner documentation it was determined how to show the velocity as a graph live, it's shown in figure 25. The velocity shifts between roughly 1 to 2 m/s the high frequency shows the current main issue with the SPAR which is the stop/start jolty motion. If this issue can be solved the SPAR will be significantly more efficient. Figure 23 shows a photo of the battery after the significant test; this was after all the voltage warnings. It is unknown why there would be voltage warnings, but the cell indicates it's at 80%.

Amendments: Determine how to turn off reverse. Understand why the SPAR wont start in water. Epoxy the thruster rudders. Learn why voltage drops are happening but battery is still full.

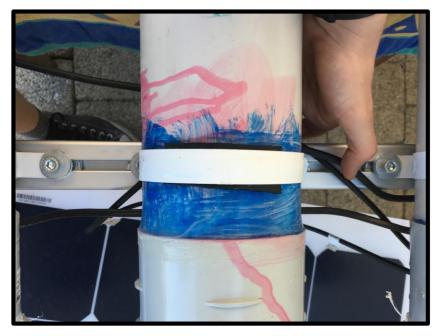
Figure 29: View of Complexity of Wires During Maintenance

- Description: Maintenance was conducted to see the effect of the testing on the SPAR, incorporate additional features and ensure that all components are in working order after finalising my report. There was a noticeable amount of corrosion in critical areas of the SPAR and is discussed in section 6.2. All the fixtures were holding steady with minimal slippage on the saddles. The black rubber stoppers held up well with little to no damage. Taking the SPAR apart took a considerable amount of time and cared due to no small number of nuts and bolts.
- Location: Home, Subiaco WA 6008
- Amendments: None, apart from corrosion SPAR was in good working order.
